**ANALYSIS OF DAMAGE TO A EUROCOPTER AS350-B2 HELICOPTER
NTSB ID ANC08FA053**

Aircraft: Eurocopter AS 350-B2, S/N 3158
Registration: N213EH
Date: April 15, 2008
Location: Sheep Mountain, Alaska
Operator: ERA Helicopters Inc.
NTSB ID: ANC08FA053

ANALYSIS OF DAMAGE TO A EUROCOPTER AS350-B2 HELICOPTER

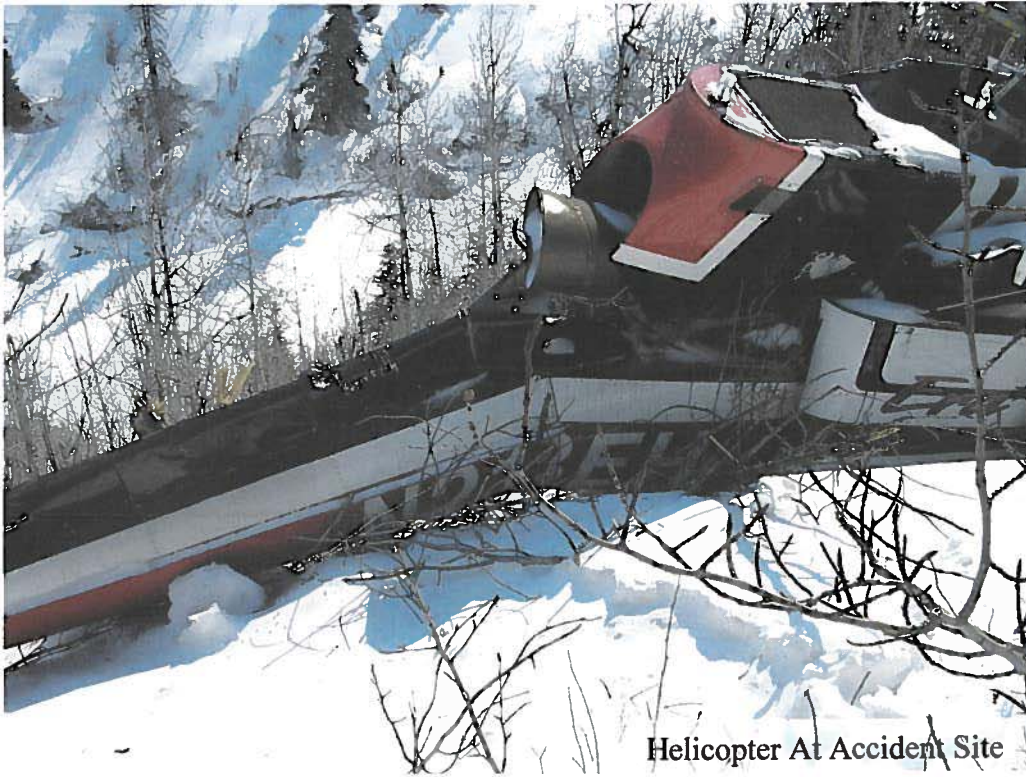
Figure 3

1. All three main rotor blades exhibit damage caused during impact with the terrain while at significant rotational speed (Figures 19 through 27). This damage occurred prior to final impact at the crash site as indicated by the lack of rotational damage to the willow brush surrounding the helicopter at the final resting place (Figures 2 through 6).

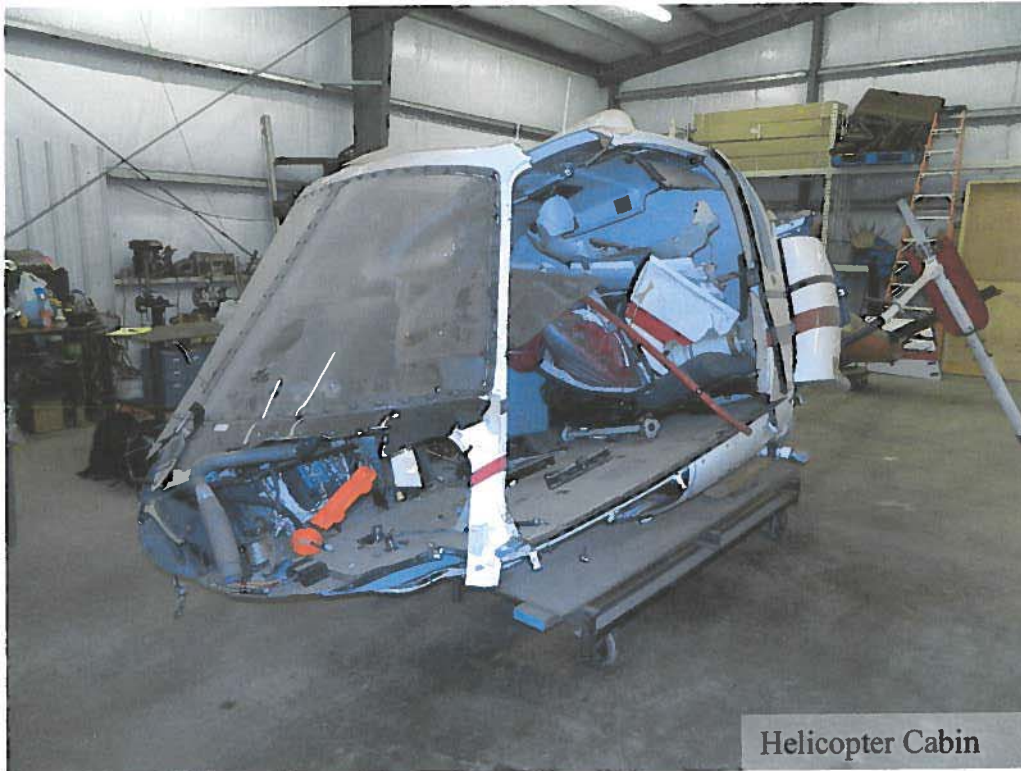
An examination of helicopter components was conducted on September 11, 2012 at a storage facility in Wasilla, Alaska. Figure 16 shows an overall view of the helicopter cabin. The forward end of the tail boom adjacent to the fuselage was buckled due to downward forces during the collision at the crash site (Figure 17). The aft end of the tail boom, including the tail rotor gearbox, was separated due to tearing of the boom (Figure 18). The engine, MGB, and MR head were not with the wreckage in Wasilla, Alaska. The MGB was examined previously and found to rotate freely. The MGB components were in good condition. The FFCL and housing panel were removed previously and

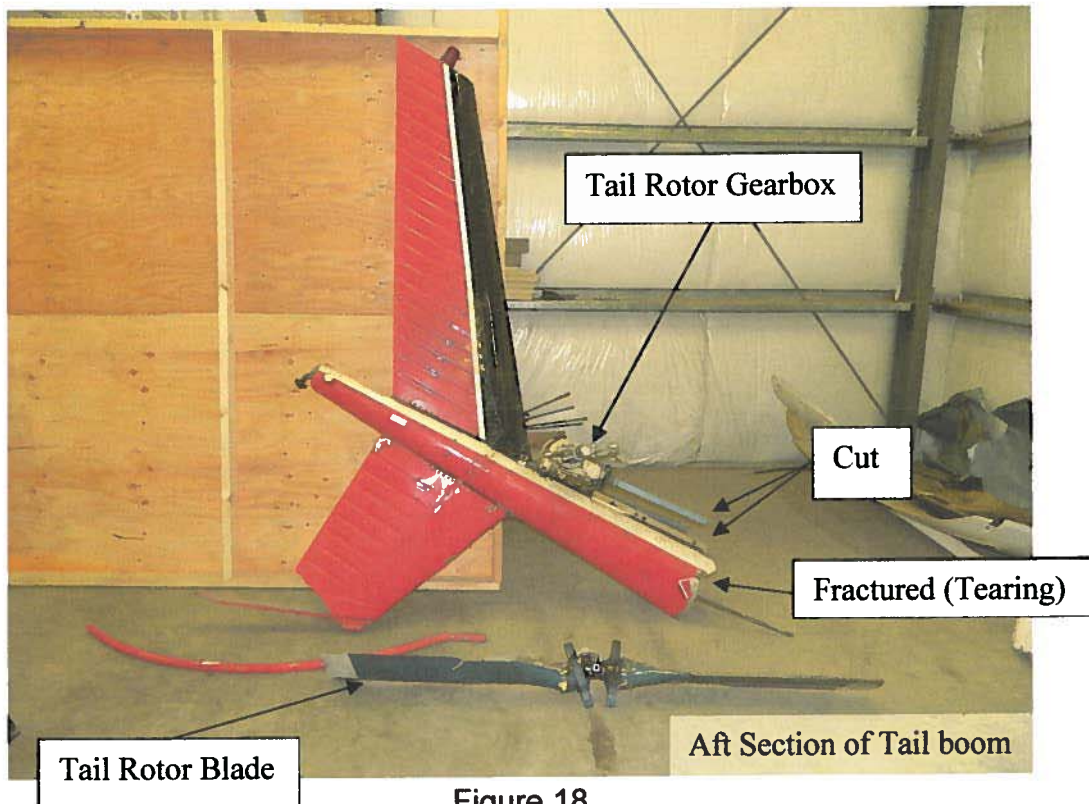
Figure 18

Accident scene photographs show downward deformation at the forward end of the tail boom and tearing of the tail boom aft of the horizontal stabilizer. Figure 17 shows the tail boom during the inspection. The end of the right horizontal stabilizer was crushed during impact with the sloping terrain. The right side of the boom and TR driveshaft cowling exhibited deformation and embedded wood from impact with a tree (Figures 37, 38 and 39). A small broken tree was located adjacent to the left side of the tail boom near the deformed area. The TR driveshaft and cowling were not impacted by a rotating MR blade during the vertical descent at the final crash site, further indicating lack of significant rotor speed.

8. The vertical impact forces at the crash site caused the tail boom to deform downward. The tail boom deflection caused the tail rotor driveshaft to separate at the spline connection between the steel shaft and aluminum shaft. Continued residual rotation of the forward (steel) segment of the TR driveshaft caused rotational damage to the aft flex coupling and TR driveshaft cowl.

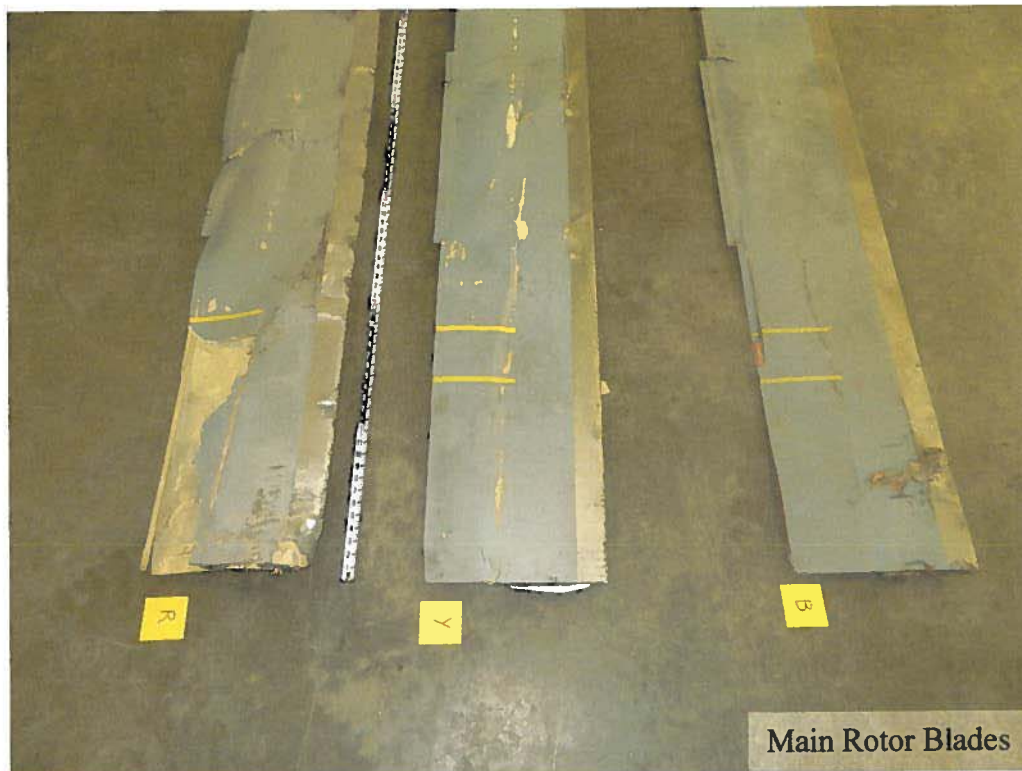
Figure 21

The AS350 helicopter has three main rotor blades that are color coded red, yellow, and blue. When viewed from above the blades rotate in a clockwise direction. Figures 19 and 20 show the MR blades during the inspection on September 11, 2012. All three blades exhibited impact damage to the leading edge, skin tearing, buckling, and separation (splitting) at the trailing edge (Figure 21). The outboard end of the red blade exhibited chordwise bending and was shattered. The abrasion strip was deformed and the tracking finger separated (Figures 22 and 23). The stainless steel leading edge abrasion strip exhibited multiple dents and chordwise abrasions caused by impact with the terrain while the blade was rotating at a significant speed. The yellow blade also exhibited chordwise bending, leading edge dents, and chordwise abrasions (Figures 24 and 25). The blue blade exhibited damage similar to the red blade but to a lesser extent (Figures 26 and 27). All three blades exhibited damage caused by impact with the terrain while at a significant rotational speed. This damage occurred prior to the final impact at the crash site as indicated by the lack of rotor speed when the helicopter impacted the sloping terrain.

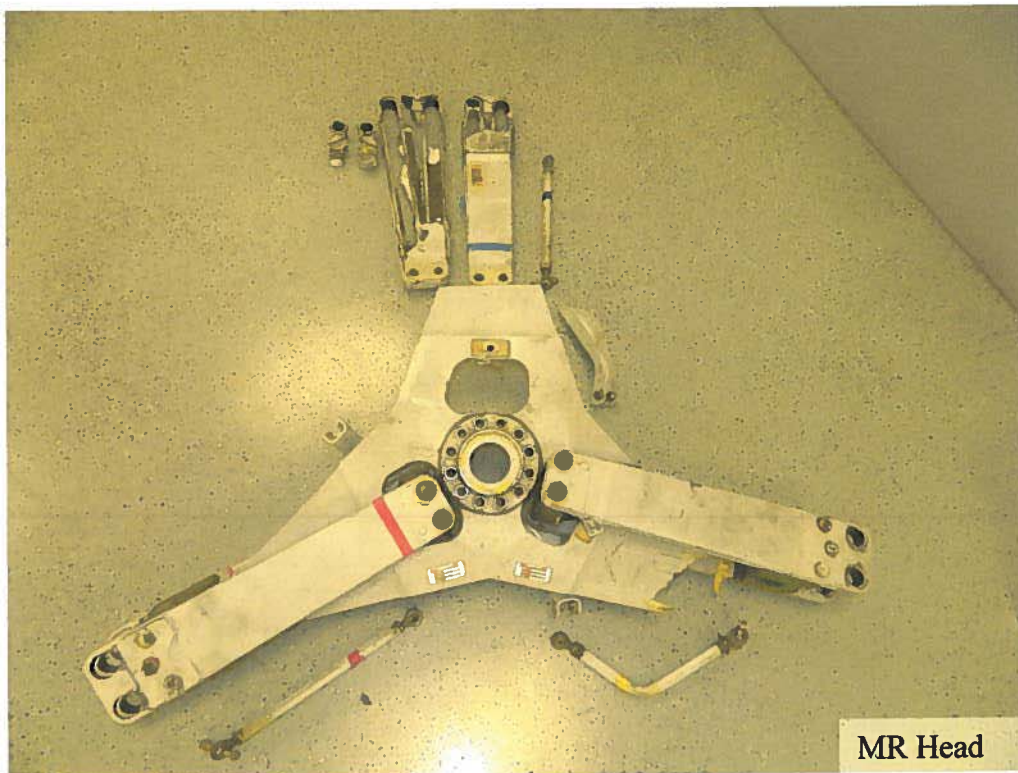
The MGB and MR head assembly were examined at ASOD. The input pinion for the MGB was rotated by hand, which caused the planet gears to rotate. There was not any indication of binding or a malfunction in the MGB. Figure 28 shows an illustration of the MR head components. Figure 29 shows the head components from the accident helicopter. The yellow star arm was fractured on a diagonal plane (Figure 30) indicating impact of the blade during powered rotation. The blue sleeves were shattered (Figure 31). The blue star arm was cut. The yellow and red sleeves were split. Damage to the head components indicates that the blades impacted the terrain while under power transferring the forces to the head and causing the damage to the star arm and sleeves.

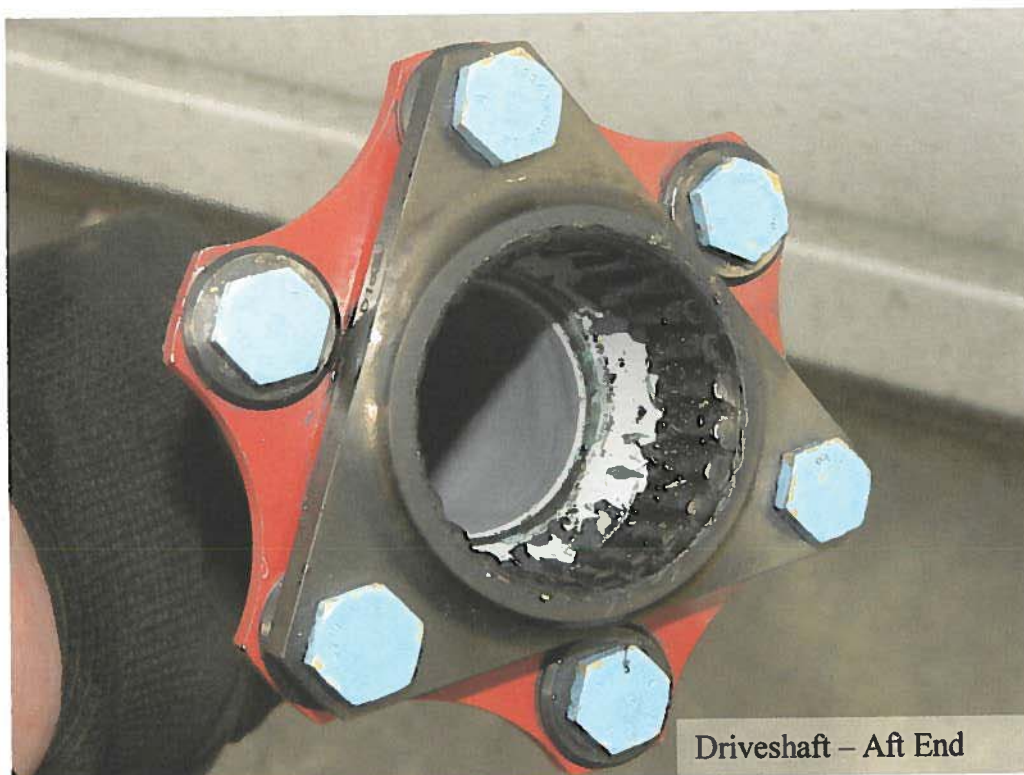
Figure 34

coupling at the forward end. Figure 32 shows the driveshaft between the engine and MGB during the September 11, 2012 inspection. The flex couplings at both ends were intact. The shaft has a rotational twist and partial fracture (Figure 33). Engineering analysis performed by Eurocopter indicates that torsional deformation to the shaft requires an overload torque in excess of 300 percent. The driveshaft rotates clockwise when viewed from the engine. The direction of twist (torsional buckles) in the driveshaft indicates that the engine was driving the shaft when the forward end at the MGB encountered a severe resistance. The severe resistance caused the engine to overload the driveshaft resulting in torsional deformation. The severe resistance was produced during impact of the MR blades with the terrain. Impact of the MR blades with terrain occurred prior to the final crash site impact and caused a substantial resistance to rotation of the blades and MGB. The engine was providing rotational power to the driveshaft at the aft end while the forward end was encountering substantial resistance during MR blade impact. The result was a twisted shaft. The twisting deformation caused the overall length of the driveshaft to shorten. The measured length of the twisted shaft was 32.2 cm, compared to the manufactured length of 34.1 cm. Shortening of the shaft by approximately 1.9 cm caused the spline coupling at the aft end of the driveshaft (Figures 34 and 35) to nearly separate from the mating splines on the power shaft assembly (Figure 36). An overlap of approximately 3.5 mm existed between the mating splines. Continued rotation of the engine power shaft caused rotational smearing at the ends of the mating splines (Figures 35 and 36) and disengagement of the driveshaft. The splines on the coupling for the engine power shaft assembly and on the driveshaft spline coupling were both damaged resulting in loss of drive to the MGB and MR blades. The coupling tube surrounding the driveshaft exhibited a small area of deformation.

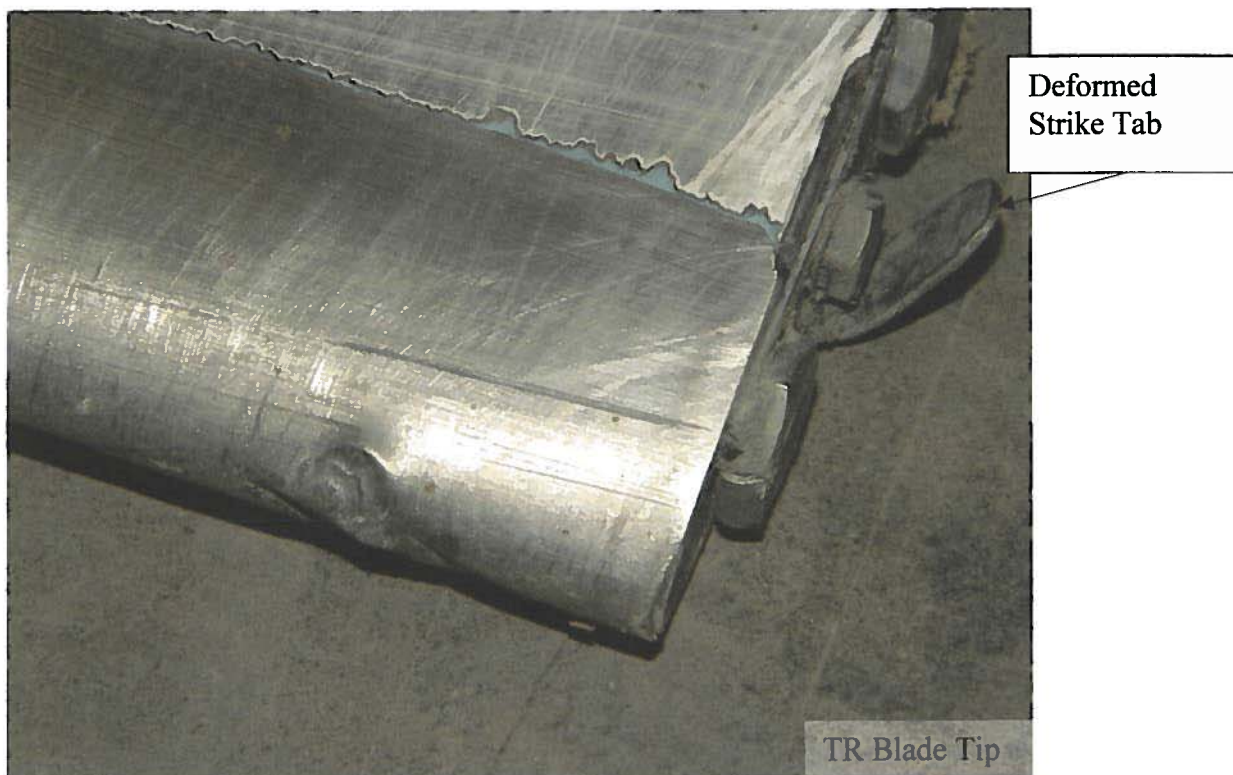
Figure 47

Figure 46 shows the TR blades adjacent to the aft section of the tail boom. The fiberglass in both blades was shattered due to impact forces. The strike tabs on both blades were bent opposite to the direction of rotation (Figures 47 and 48). The leading edge abrasion strip on one blade was dented due to contact with the terrain during blade rotation (Figure 47). Both blades exhibit chordwise abrasions. The blades also exhibit contact marks from flapping.

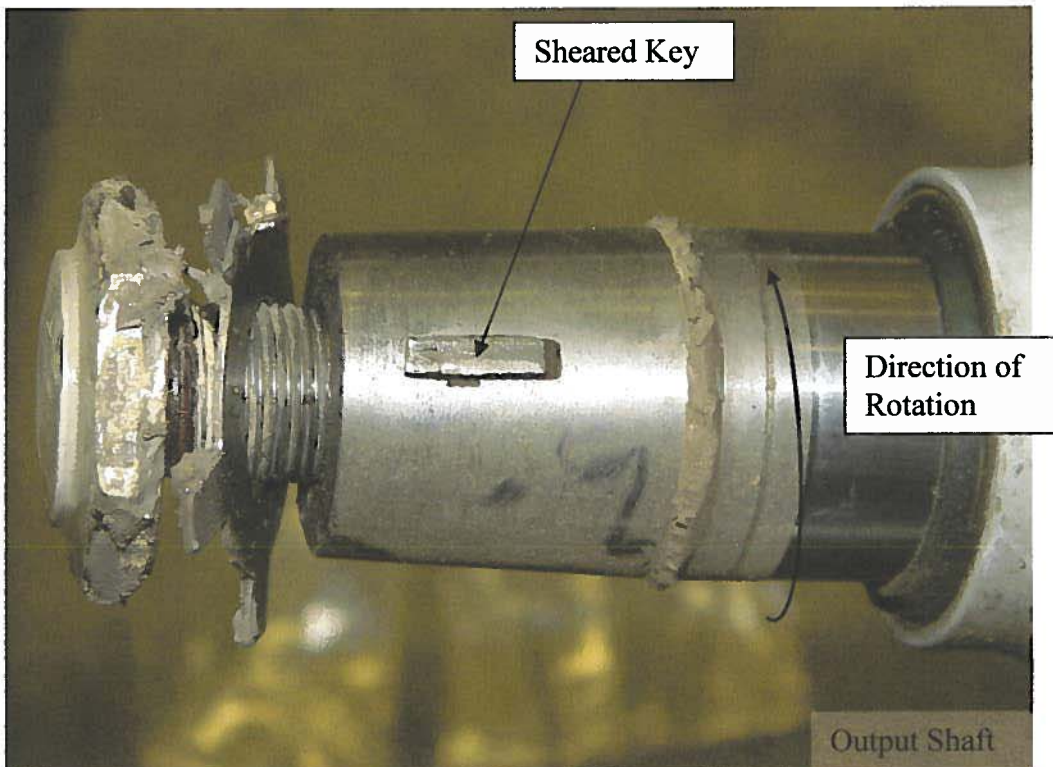
Figure 50

The tail rotor gearbox rotated freely. The aluminum driveshaft and pitch control tube were cut previously. The TR hub is installed on the gearbox output shaft and secured with a bolt and key (Figure 49). The key between the output shaft and hub had sheared due to overload forces (Figures 50 and 51). The output shaft rotates counter-clockwise when viewed from the end of the shaft. The direction of shear on the fractured key was opposite to the direction of shaft rotation. Either there was a significant acceleration of the output shaft caused by suddenly available engine power when the MR blades contacted the ground and the engine-to-MGB driveshaft separated, or the TR blades impacted the ground at the same time as the MR blades during the initial ground contact. Damage to the output shaft key most likely occurred prior to the final ground impact at the accident site that caused boom deformation, separation of the TR driveshaft, and blade damage.

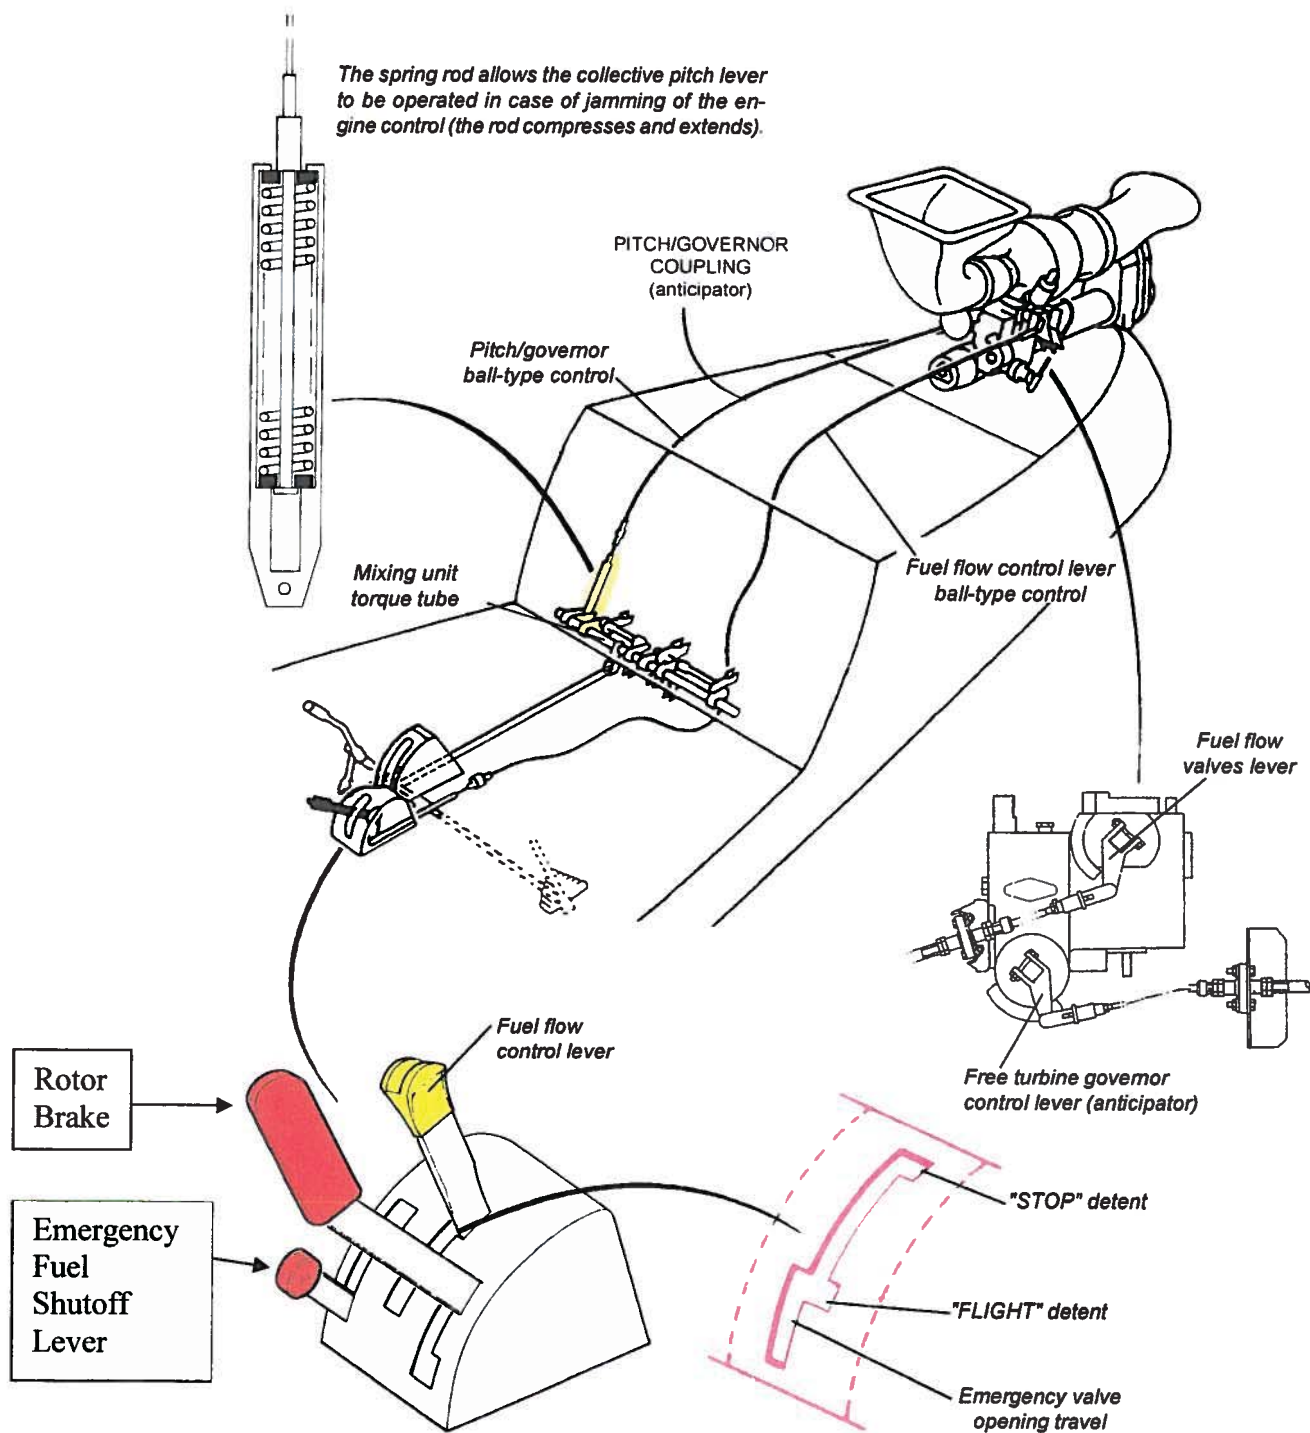
Figure 52 shows an illustration of the floor mounted controls, including the fuel flow control lever, and linkage to the engine. The FFCL has three positions – “stop” (off) and start, “flight,” and “emergency” position. The emergency position is below the flight position and allows for manual control of the fuel flow. Following the accident the FFCL was observed to be out of the flight detent and rotated down (forward) toward the emergency position (Figure 10). In order to shift the FFCL from the flight detent to the emergency position, the lever must be moved laterally 0.4 in. to the right, then rotated down 0.7 in. After the accident the FFCL was found to be out of the flight detent and rotated down (forward) approximately 0.3 in. The emergency fuel shutoff lever was found in the full aft detent (off) position. The wire securing the shutoff lever in the forward position was broken. The FFCL and housing panel were removed after the accident. Figures 53 and 54 show the cockpit floor where the levers were installed. Figure 55 shows the components stored in a separate box. Slight wear marks were present on the side of the lever from contact with the cover slot during use. The lower end of the FFCL was disconnected previously from the linkage. Figure 56 shows the linkages for the three levers under the cockpit floor. Continuity of the FFCL linkage was checked back to the engine (Figure 57). The rod was bent adjacent to the fitting. The cable could be moved manually when the fitting that attaches to the FFCL was pushed rearward and forward. Cable movement was limited by the bend in the rod.

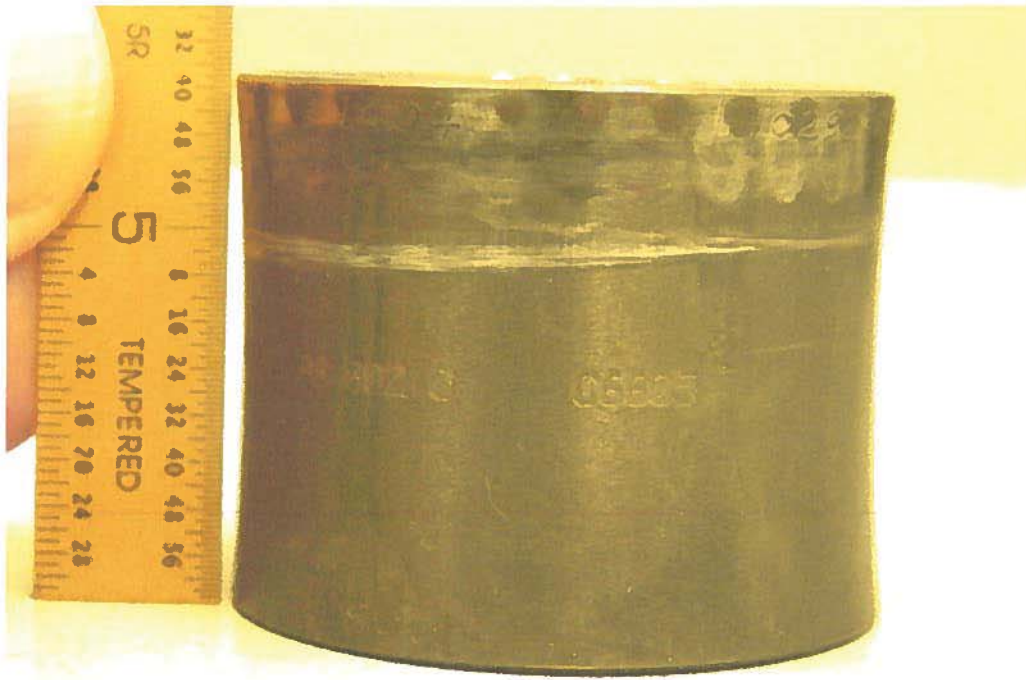
Figure 61

2. The twisted engine-to-MGB driveshaft (Figure 32), over-rotated module No. 5 drive retaining nut (Figure 60), and deformed muff coupling (Figure 61) all indicate significant engine power applied to the engine gearbox and driveshaft when a substantial resistance was encountered. Damage to the main rotor blades is the only indication of a substantial resistance that would explain the shaft and coupling deformation and nut over-rotation. The main rotor damage occurred during flight and prior to the final crash site.

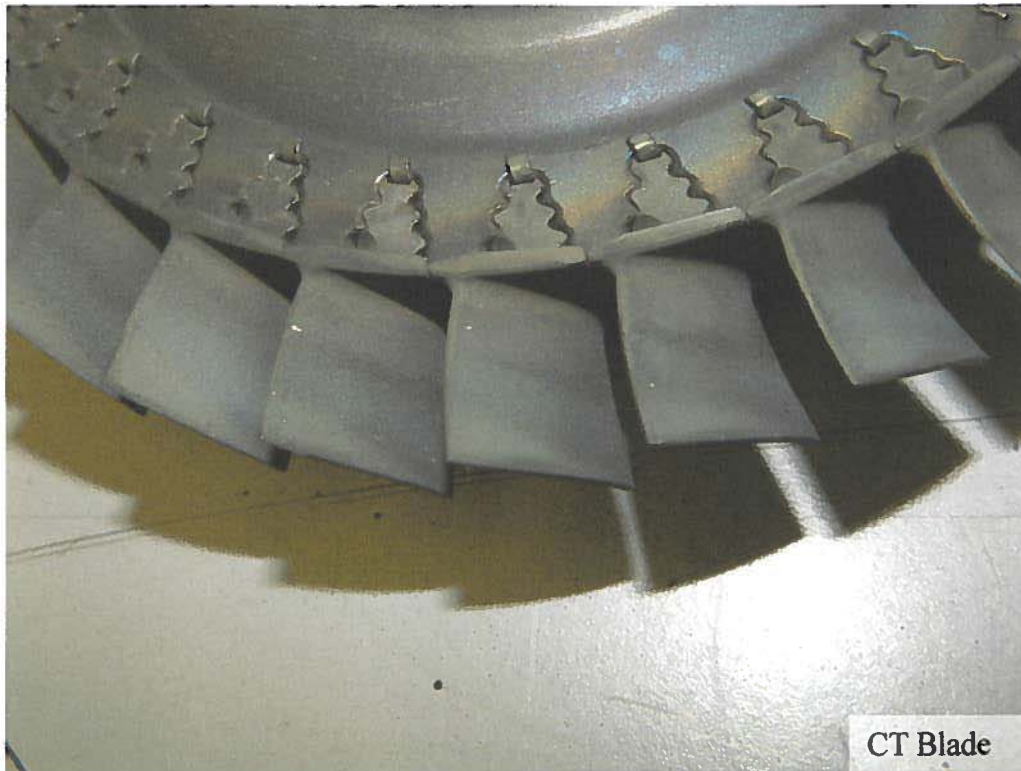
Figure 67

Figures 64 and 65 show the first and second stage CT gas generator wheels, respectively. The blades did not exhibit evidence of overheating. Metal splatters were on the inlet nozzle vanes (Figure 66) and CT wheels (Figure 67). The metal splatters occurred due to rubbing of the compressor axial blades and impeller (Figure 68) during engine operation, most likely when the PT wheel lost its blades. The CT wheels also exhibited minor blade tip rub.
